Madison Schools –Comprehensive Assessment Study

Architectural Assessment October 6, 2015

TOWN CAMPUS EARLY LEARNING CENTER

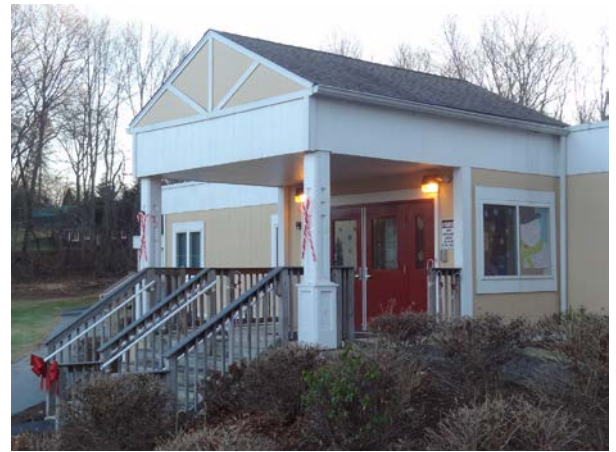
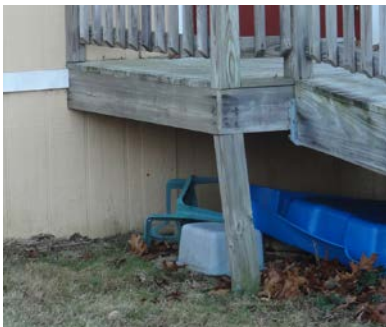
Wood Platform- Left 4x4 wood post on leg of ramp platform near play yard is bent inward and needs to be straightened and secured.

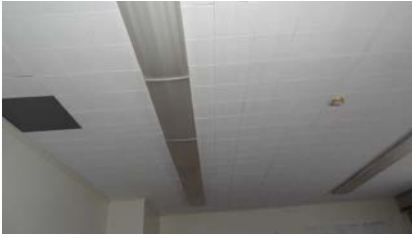
Ceilings - Most spaces have 1x1 ceiling tiles installed and were noted to be in fair to poor condition (See Hazardous Material section). Suspended acoustical ceilings were installed in the modular classrooms and were noted to be in fair to good condition on average.

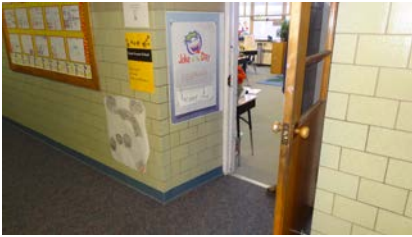
Doors and Frames - Solid core wood doors are mounted in hollow metal door frames throughout the building. Many doors have shown signs of wear and should be repainted but are in fair condition.

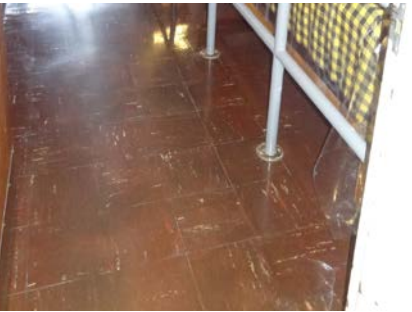
Flooring - Majority of the flooring is vinyl asbestos tile and is located throughout the building. (See Hazardous Section) Carpet has been installed in some of the classrooms, kitchen and Hallways over existing tile. These are in fair to poor condition. Platform or Stage flooring is a stained wood and is in good condition but stage is used as an office.

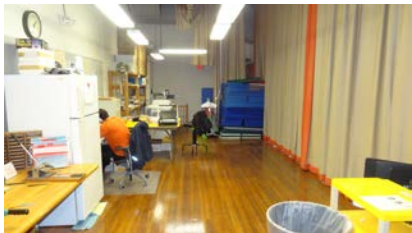
Casework - The casework in most classrooms and offices are old and showing signs of age. Doors to closet areas are hard to open and hardware and hinges are worn out.

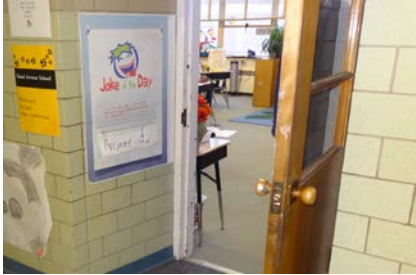
Pull Side of Doors - Pull side on entry doors to the classrooms in the main structure are recessed and don't have required 18 inch clearance which does not meet the ADA accessibility code. Modular classrooms have the required clearances.

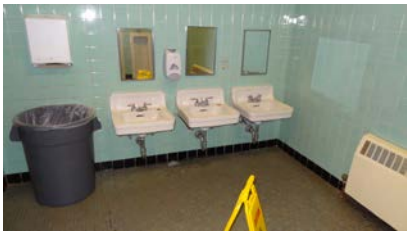
Toilet Facilities - Boys, Girls gang restrooms are non-compliant for accessibility, fixtures types and clearances at doors and fixtures.

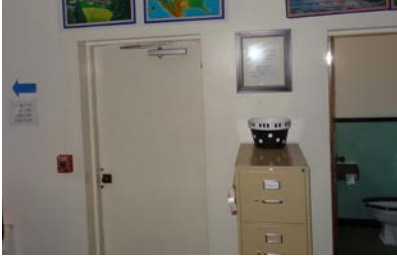
Panic Hardware: Exterior door from Special Needs, Room 1A has a knob on door and is required by code to have push bar or panic hardware.

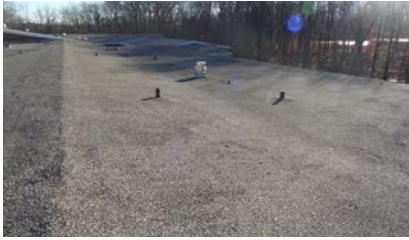
Roof - The roof is a modified built-up tar and gravel asphalt roofing system in all areas with the exception of the Portable or Modular units which is a EPDM roof system. There are areas of ponding indicating low areas between the 1957 original structure and the 1963 addition. It has been reported that the most recent roofing work on the Main building was performed on May 1st, 1982. Leaks have been reported in these areas but overall the roof appears to be in fair condition.

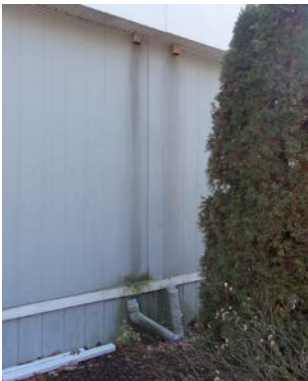
Portables or Modular Classrooms - The portables were installed in 2000 and are showing signs of age.

- Down spouts or roof drains are missing or detached on the North and South sides of the modular building.
- Stairs and ramp are aged and weather beaten. Handrails are not properly secured to either building or railings. (see ADA/ Accessibility Section)

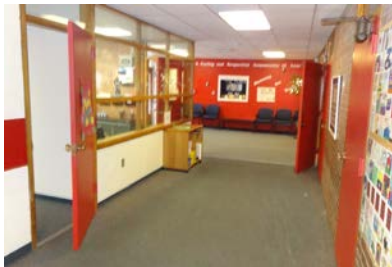
Door Knobs - Multiple doors throughout building have knobs on doors and are not code compliant. Knobs should be removed and replaced with lever type hardware.

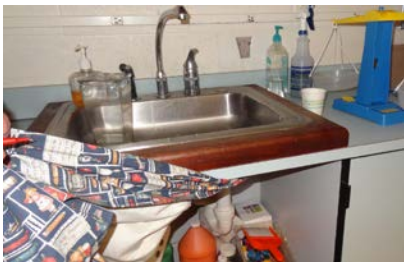
Sink Fixtures - Fixtures on the sinks in the classrooms are not ADA code compliant. Fixtures are required to be no more than 11 inches from the front edge of counter.

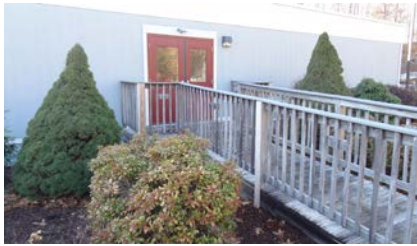
Exterior Ramp - Exit ramp from portable classrooms is non ADA compliant. The handrails do not extend at top or bottom of ramp.

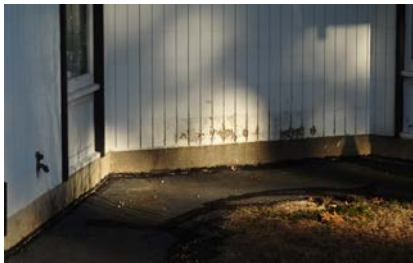
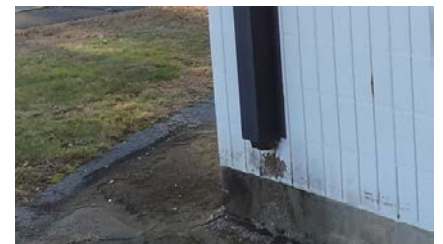
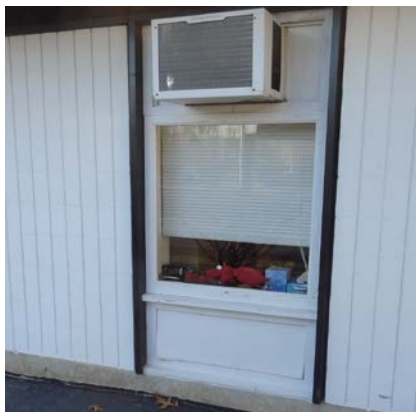
Exterior Walls - Exterior walls are painted block and are in fair to good condition. A few areas around structure are in need of attention. Paint chipping or peeling and need repaired at base of panels below down spouts.

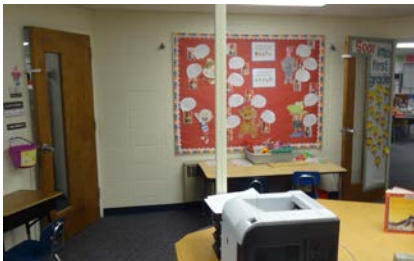
Door Knobs - Multiple doors throughout building and exterior doors from classrooms have knobs on doors and are not code compliant. Knobs should be removed and replaced with lever type hardware.

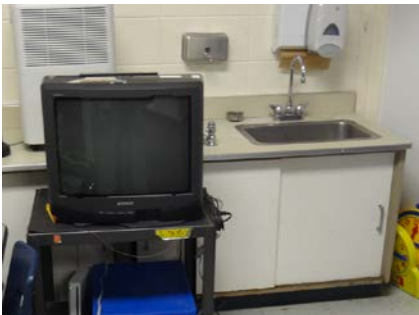
Sink Fixtures - Fixtures on the sinks in the classrooms are not ADA code compliant. Fixtures are required to be no more than 11 inches from the front edge of counter.

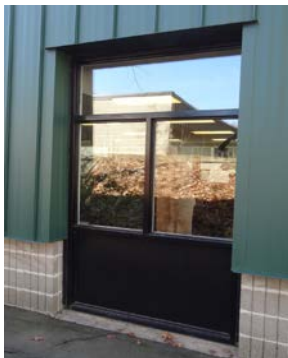
Exterior Walls - Exterior walls consist of 8" scored concrete blocks, stucco and metal siding. Overall exterior in fair condition. Multiple areas where re-pointing was completed and in poor workmanship.

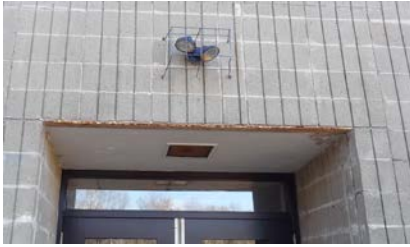
Lintels - Lintels above the doors and windows on the North-east side of the 1971 addition are rusting.

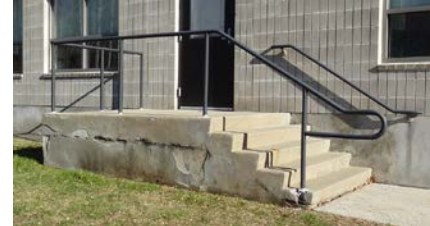
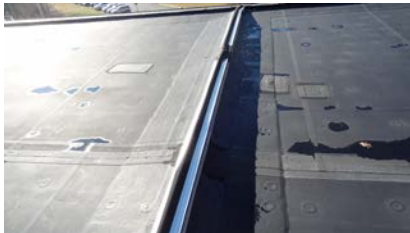
Spalling Concrete - - Concrete spalling and or cracked in multiple areas around structure.

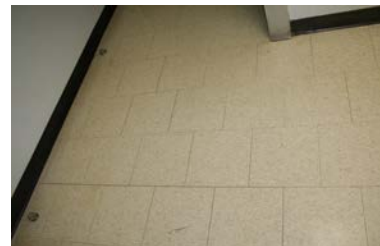
Flooring - VCT flooring in corridors, Classroom and Kitchen are warping, chipping and failing at the edges of the tile. Carpet in classrooms are in good condition.

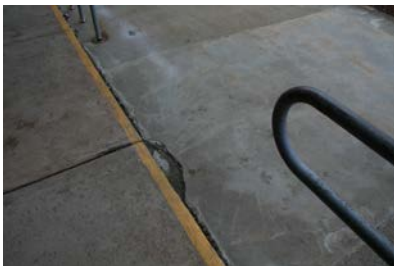
Main Entry Ramp - Concrete at main entry ramp is cracking and broken in a couple o areas and rust stained below handrails. Paint on handrails chipped and peeling.

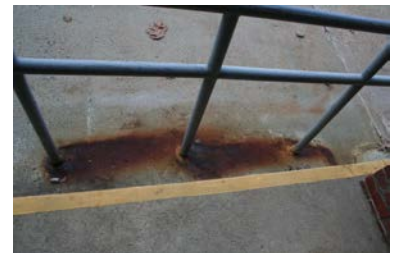
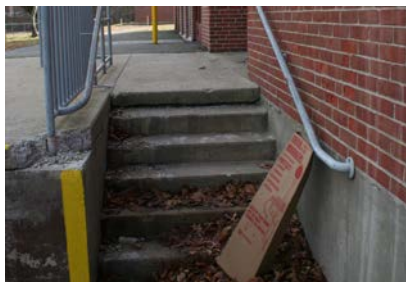
Loading Dock - Concrete at loading dock stairs and around platform is cracking, chipping and spalling. Lintel at receiving area entry is rusting. Broken panel below window.

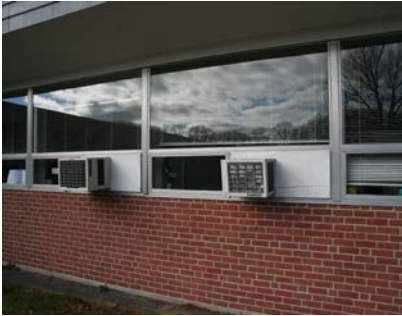
Windows - Existing window units are aluminum framed, single glazed windows and are original. Window AC units also appear to be in poor condition. Painted peeling around wood frame and plywood panel and metal exterior casing is dented or damaged. Glass block windows around Auxiliary Gym are broken and mismatched.

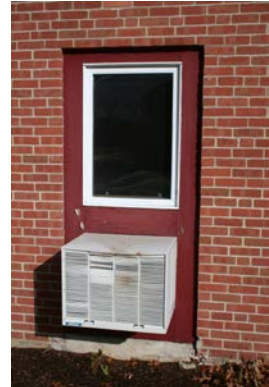
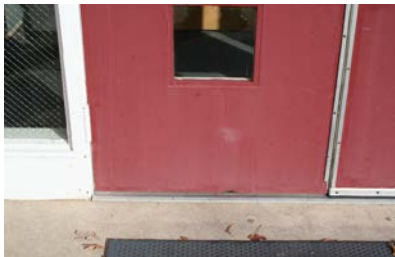
Doors and Frames - Exterior doors appear original to building and are in fair to poor condition. Doors and frames are either fading, oxidizing or rusting and missing either weather stripping or bug sweeps.

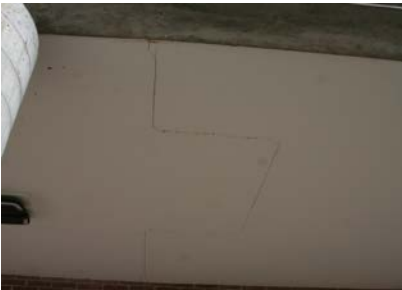
Soffits - Soffits at the Main Gymnasium entrance is warping, bowing and coming loose at the edges and cracking at the seams.

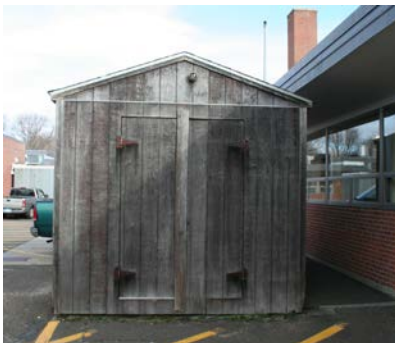
Exterior Wood Sheds - Shed structure near Greenhouse, Tennis courts and outside of Science rooms 40 and 41 are in poor condition. Plywood is flaking and rotting. Paint is fading and chipping.

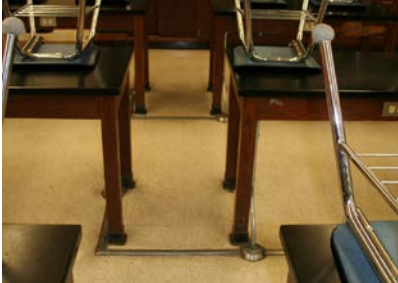
Trip Hazards - In the Science rooms there electrical running across floor to each of the desks which causes a trip hazard.

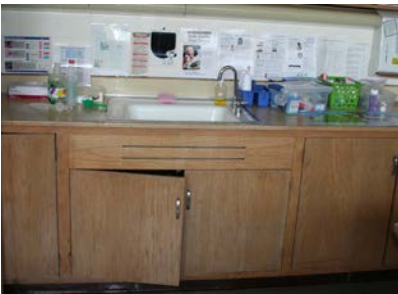
Sinks - Fixtures at the sinks in the Faculty Room, Science Room and Nurses office are not ADA compliant. Fixtures on sinks are mounted more than 11 inches from front of counter and fixtures need to be lever or auto flow type.

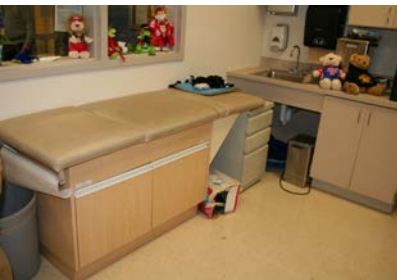
Sink Clearances- Sink in Nurse exam room is blocked by exam bed and filing cabinet. Clear area to allow access..

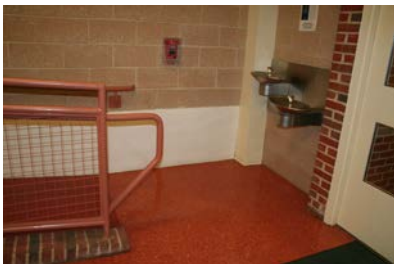
Ramps - 2 Ramps at the entrance near the Media Center have drinking fountains at the bottom. Handrail extensions appear to extend into the 5 foot clearance area of the drinking fountains. Recommend wrapping the handrail around the guardrail instead of extending out the 12".
