Madison Schools –Comprehensive Assessment Study

Architectural Assessment October 6, 2015

TOWN CAMPUS EARLY LEARNING CENTER

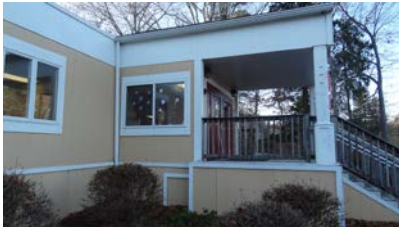
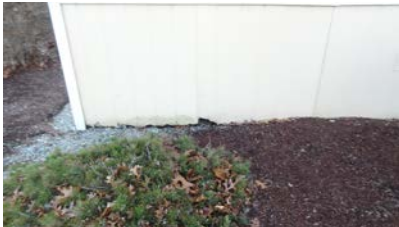
Exterior Walls - The exterior walls of the 2000 building consist of painted wood panels and are assumed that these walls insulated. The exterior walls appear to be in good condition but showing signs wear and rot at the bottom of the wood skirt around the entire structure and some remedial work required to either repair or replace panels..

Wood Platform- Left 4x4 wood post on leg of ramp platform near play yard is bent inward and needs to be straightened and secured.

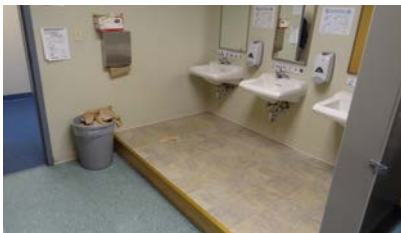
Toilet Facilities - Boys and Girls are not ADA accessible because of platform below sinks which prohibit a wheelchair from gaining access to the sinks. Staff restrooms are compliant for accessibility.

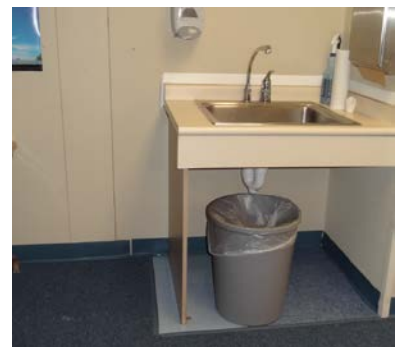
Sink Fixtures - Fixtures on the sinks in the classrooms are not ADA code compliant. Fixtures are required to be no more than 11 inches from the front edge of counter.

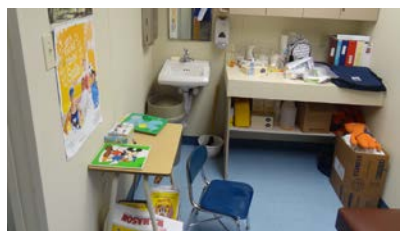
Sink Clearances - Nurses office sink has furniture and trash bin in front of the sink which prohibits access.

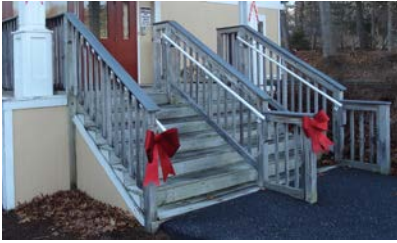
Exterior Stairs and Ramps - Do Not meet current ADA requirements.

- Main Entry stairs and the stairs on the North side of the building exiting Room #1 do not have extensions on the handrails at the top or bottom as required per code.
- Rear Entry on South side and the East side entry near the play yard have a ramp with non compliant handrails. Per code ramps are required to have handrails with extensions at top and bottom of ramp.
- Main Entry ramp does not have handrails. Ramps with a slope great than 1:20 are required by code to have handrails. Verify slope and install handrails if slope is greater than 1:20.

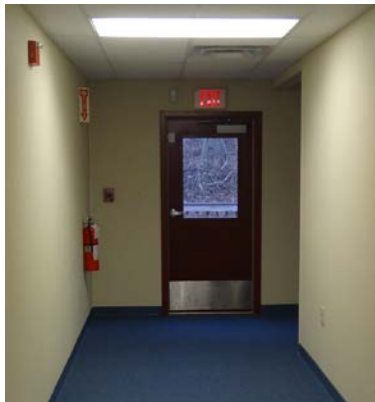
Panic Hardware: Corridor exit door on the south side of the building is required to have push bar or panic hardware. Per code, exit doors in a building with 100 or more people are requires to have panic hardware.

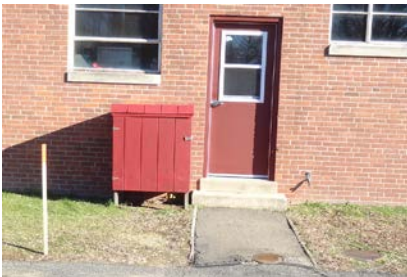
Exterior Doors - Multiple exterior doors exit to a step down area and not a platform or ramp.

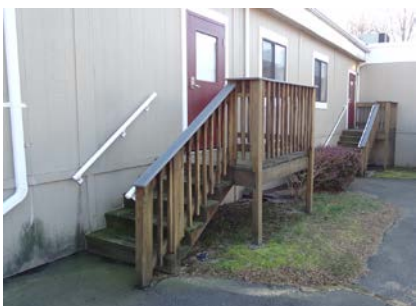
Exterior Stairs - Do not meet current ADA requirements. Rear Entry stair from modular classrooms do not have code compliant hand or guardrails with extensions top or bottom and stairs from Gymnasium do not have any handrails.

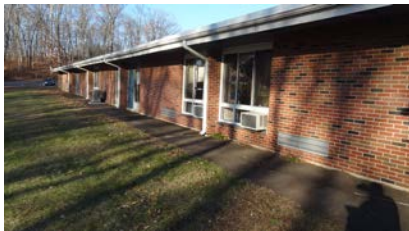
Exterior Walls - The exterior walls of the 1957,63 and 88 structure consist of brick masonry with concrete masonry unit backup. The exterior masonry walls appear to be in good condition showing no significant need of remedial work with the exception of some staining and minor cracks. Again, these can be treated, cleaned and patched to provide a more aesthetically pleasing appearance.

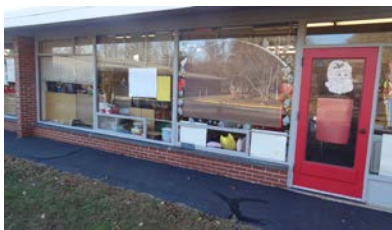
Windows - Window in the 1953 Structure metal framed, single glazed windows and are original. Windows to the classrooms in the front of the school are large not ideal for security purposes. They are also not energy efficient and appear to be in fair to poor condition.

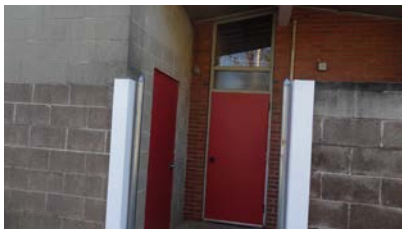
Doors and Frames - Exterior hollow metal doors and frames are original to the year the structures were built and doors and frames are showing signs of wear from age and are fading and hardware does not meet the current codes. (see ADA/ Accessibility section) They appear to be in fair to poor condition.

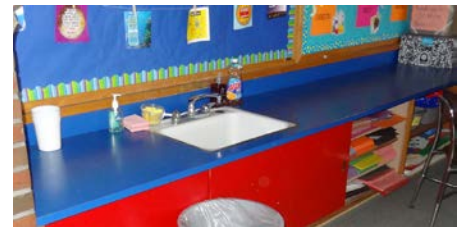
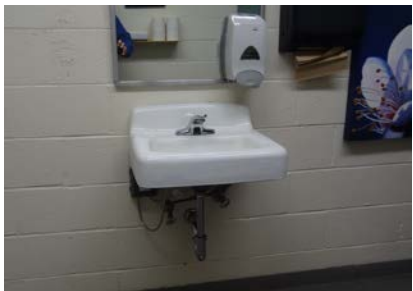
Pipe Insulation - pipe insulation miss below ADA sinks in restrooms and classrooms.

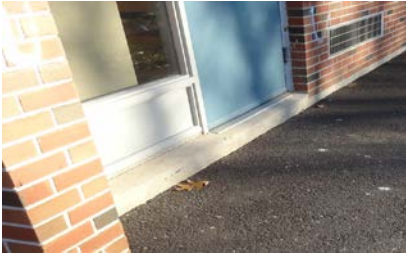
Exterior Doors - Multiple exterior doors, around entire building, exit to a step down area and not a platform or ramp.

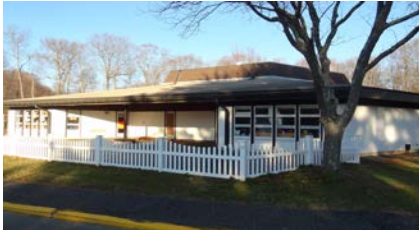
Exterior Walls - Exterior walls are painted block and are in fair to good condition. A few areas around structure are in need of attention. Paint chipping or peeling and need repaired at base of panels below down spouts.

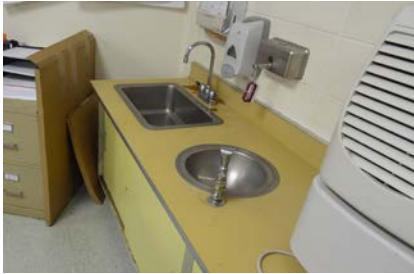
Laminated Casework - The laminate on the casework in almost all classrooms and offices are old and showing signs of age and are chipping or peeling.

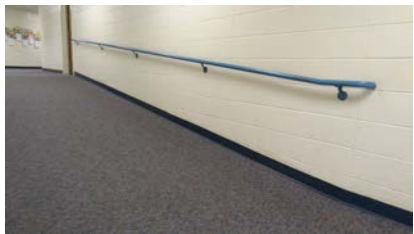
Ramp - Ramps in corridors are steeper than 1:12 which exceeds the maximum slope for means of egress ramps.

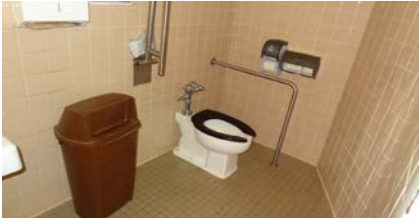
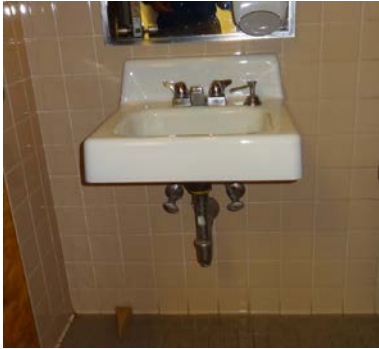
Toilet Facilities - Boys, Girls and Staff restrooms are non-compliant for accessibility, fixtures types and grab bars. Door width to staff H.C. restroom is too narrow and knob on door.

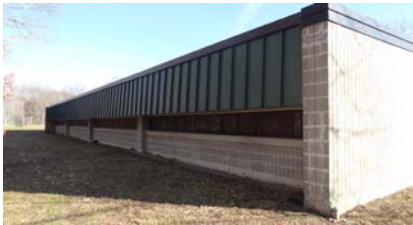
Exterior Walls - Exterior walls consist of 8" scored concrete blocks, stucco and metal siding. Overall exterior in fair condition. Multiple areas where re-pointing was completed and in poor workmanship.

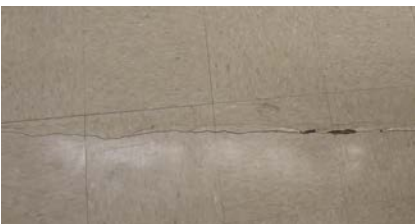
Flooring - VCT flooring in corridors, Classroom and Kitchen are warping, chipping and failing at the edges of the tile. Carpet in classrooms are in good condition.

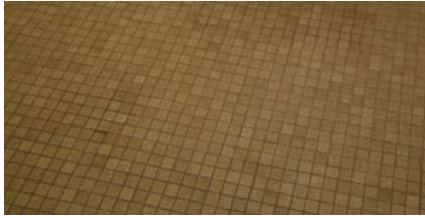
Ceramic Tiles - Generally located in toilet rooms, these appear to be in good condition.

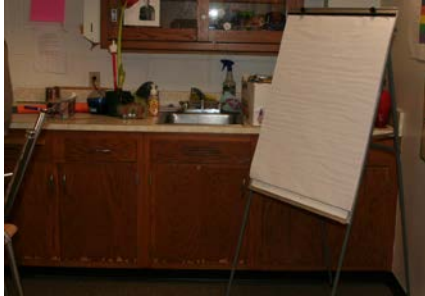
Casework - The casework in almost all classrooms and offices are old and showing signs of age and are chipping.

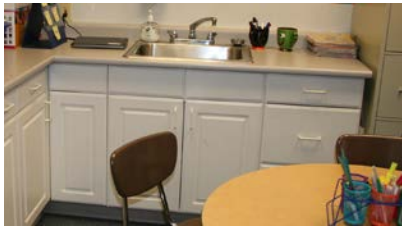
Sinks - Sinks in classrooms and workroom do not meet ADA rerequisites. Fixtures on sinks are mounted more than 11 inches from front of counter. Pipes below sinks in do not have pipe insulation.

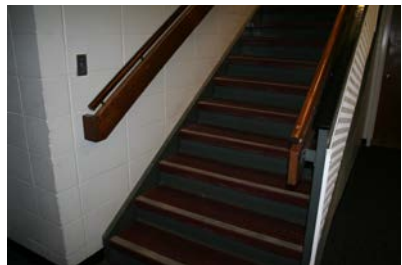
Stairs - Stairs do not have the required handrails and extensions at top or bottom.

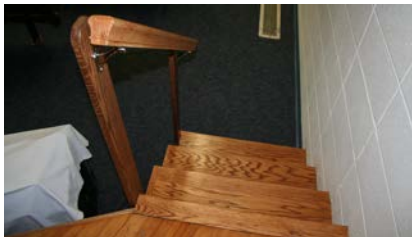
Stage or Platform Stairs - Platform has 4 risers up to the stage. There are no code compliant handrails or extensions at the top or bottom of stairs as required per current codes.

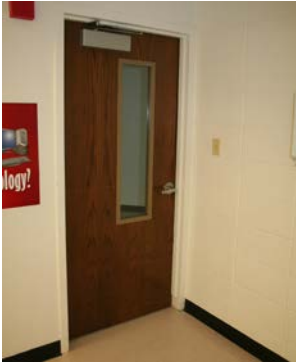
Push Side of Doors - Push side on entry doors to the some of the classrooms door does not meet the ADA accessibility code.

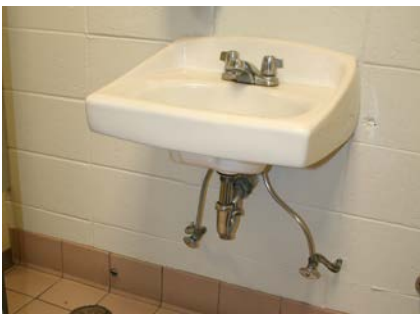
Lavoratory Sinks- Some of the ADA accessible sinks do not have the required fixtures or pipe insulation on the pipes below sink.

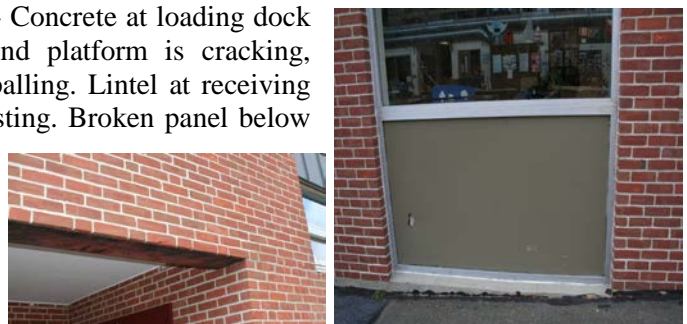
Loading Dock - Concrete at loading dock stairs and around platform is cracking, chipping and spalling. Lintel at receiving area entry is rusting. Broken panel below window.

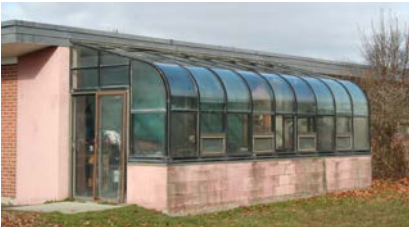
Green House - Painted concrete block at the base of the green house is stained. Sliding screen door on green house is ripped and rusted. Recommend replacing sliding glass door with a more secure door.

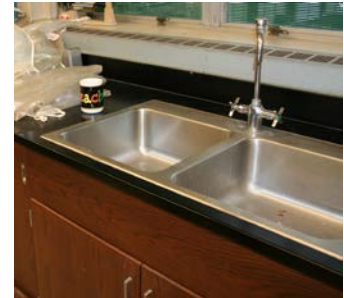
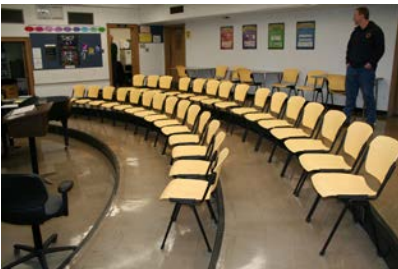
Platform Access - No access to all levels in the Band and Music practice rooms. Entrance doors are located at the top level of the platforms and there are no ramps or access to the lower level.

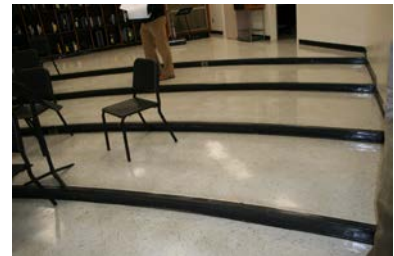
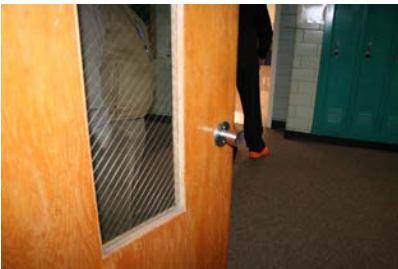
Knobs on Doors - Some of the doors on the interior and exterior have knob type hardware which require lever type.

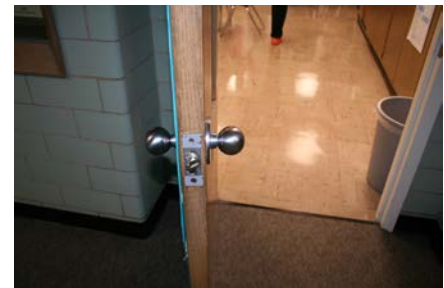
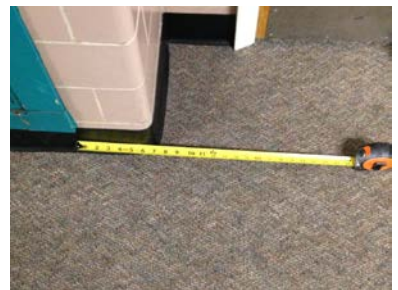
Pull side Door Clearance - Pull side of door on multiple classrooms and misc. closets and restrooms throughout the building do not meet the required clearance of 18" clear. Approximately 25 classrooms and 10 miscellaneous spaces do not meet code.

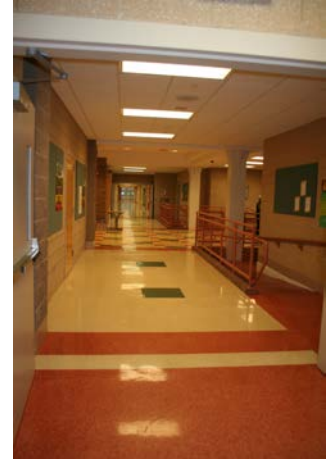
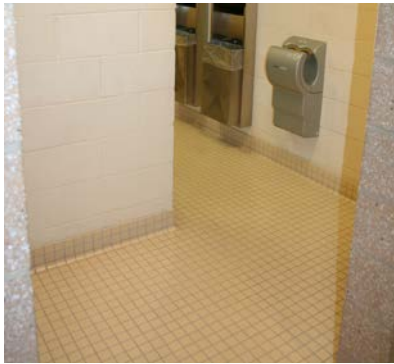
Flooring - Carpet flooring in Classrooms, Media Center, Computer Rooms and Offices areas. Tile flooring in all other spaces with the exception of the shop areas which have polished concrete floors. We were informed that the carpet flooring has been coming apart at seams and has been an ongoing problem. Carpet coming apart at the seams was very apparent in the Media Center and the Computer Room. All other flooring appears to be in good condition.
